Debris/Ice/TPS Assessment and Integrated Photographic Analysis Of Shuttle Mission STS-100

**DEBRIS/ICE/TPS ASSESSMENT
AND
INTEGRATED PHOTOGRAPHIC ANALYSIS
OF
SHUTTLE MISSION STS-100**

April 19, 2001

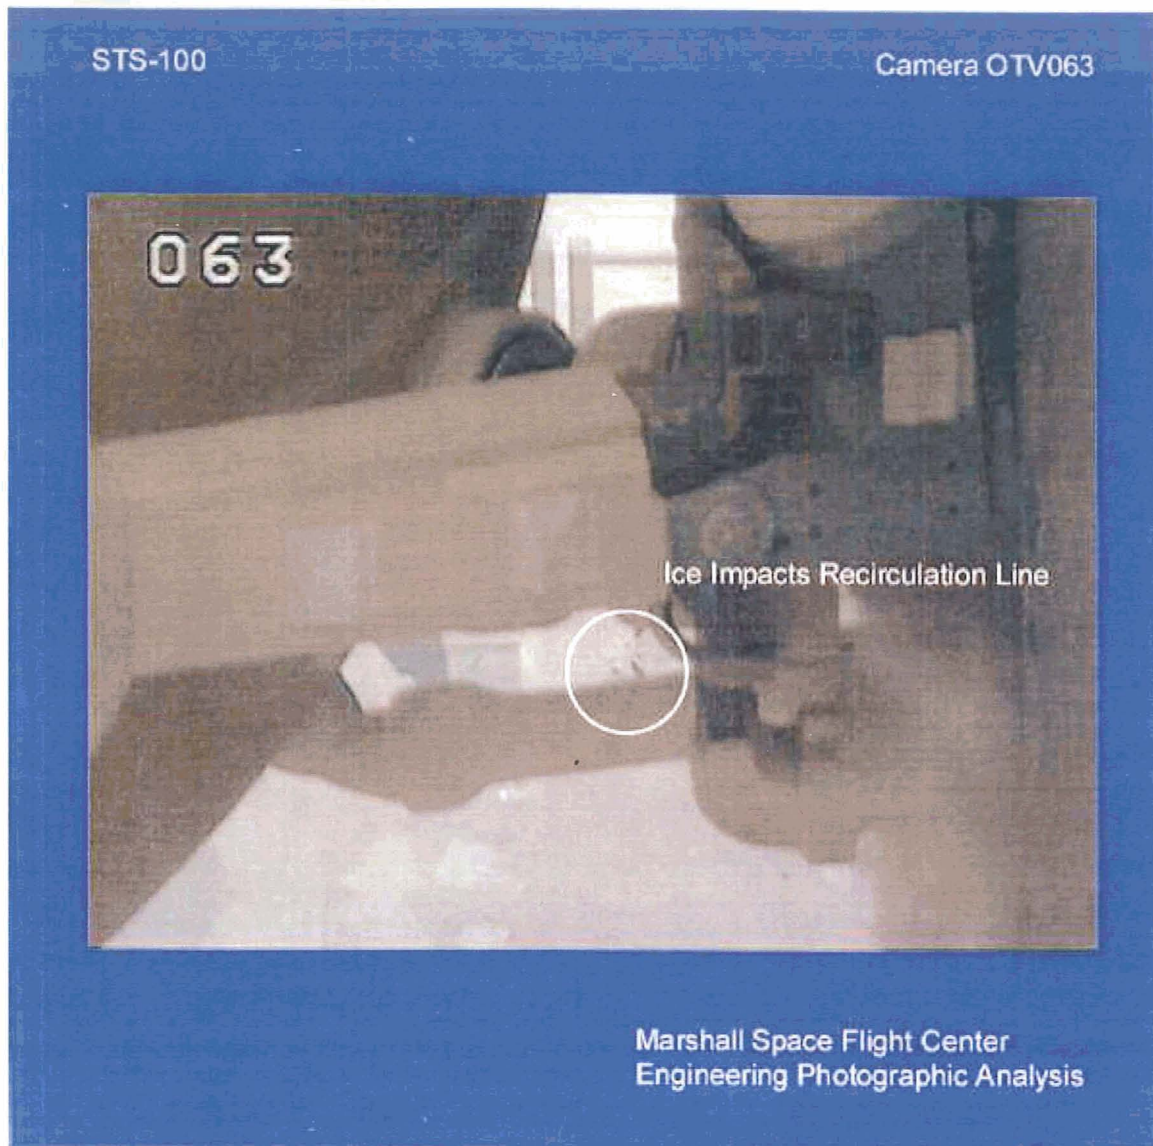
Figure 3. Ice/Frost Impacts LH2 Recirculation Line

Ice/frost from the 17 inch LH2 Disconnect was observed to strike the LH2 recirculation line. No damage was noted.

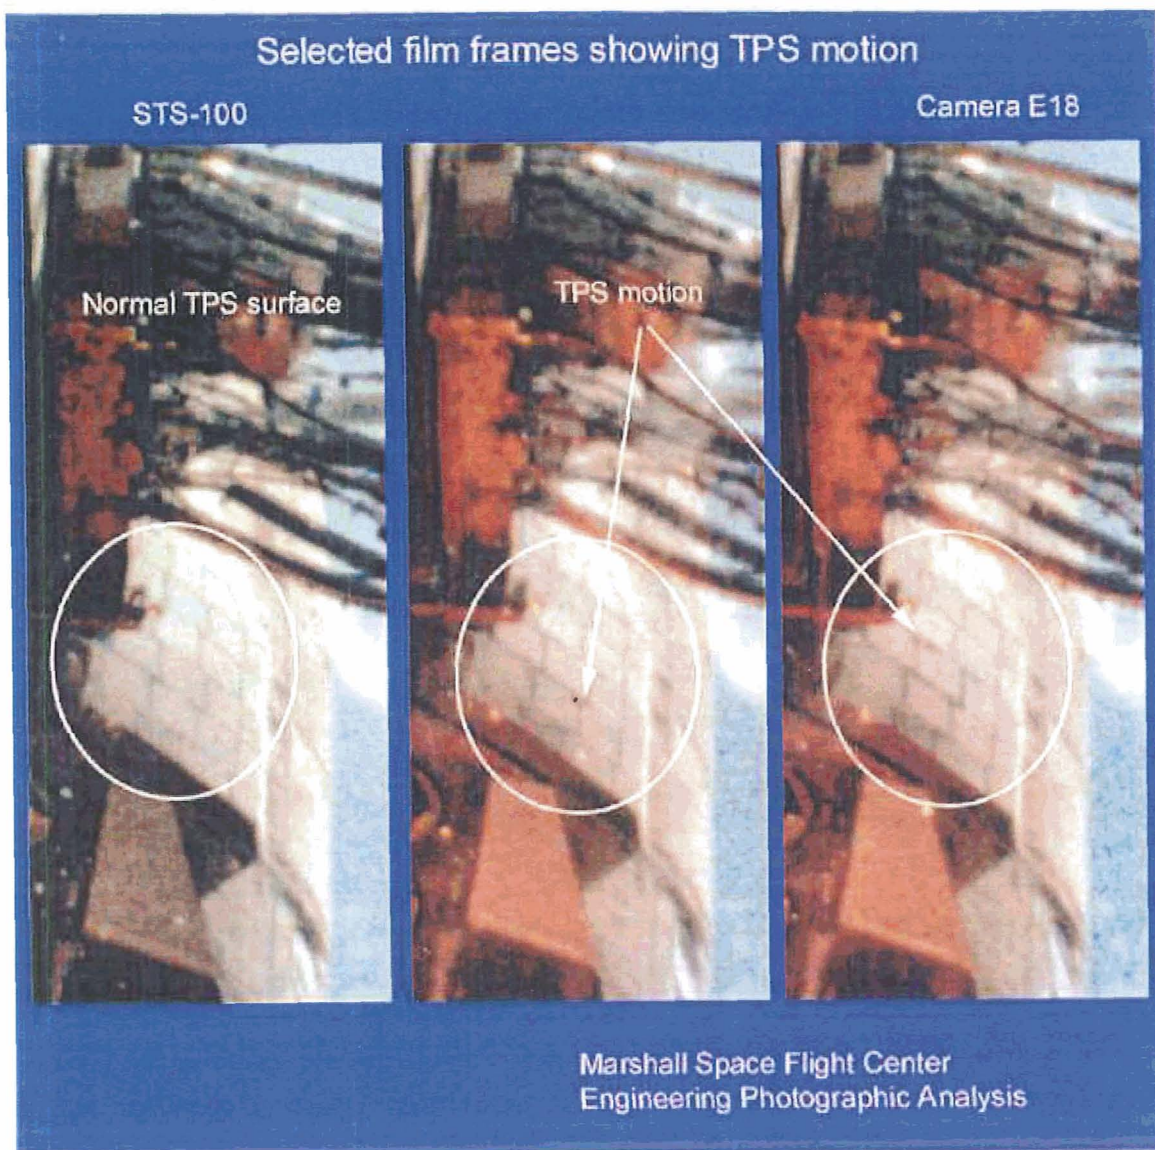
Figure 6. Motion of TPS on Left Stinger Pod

A pronounced pulsing and rippling motion of the TPS on the bottom panel of the Left Stinger Pod was observed, starting at 109:18:40:38.386 UTC and lasting for approximately 0.5 seconds during SSME startup.

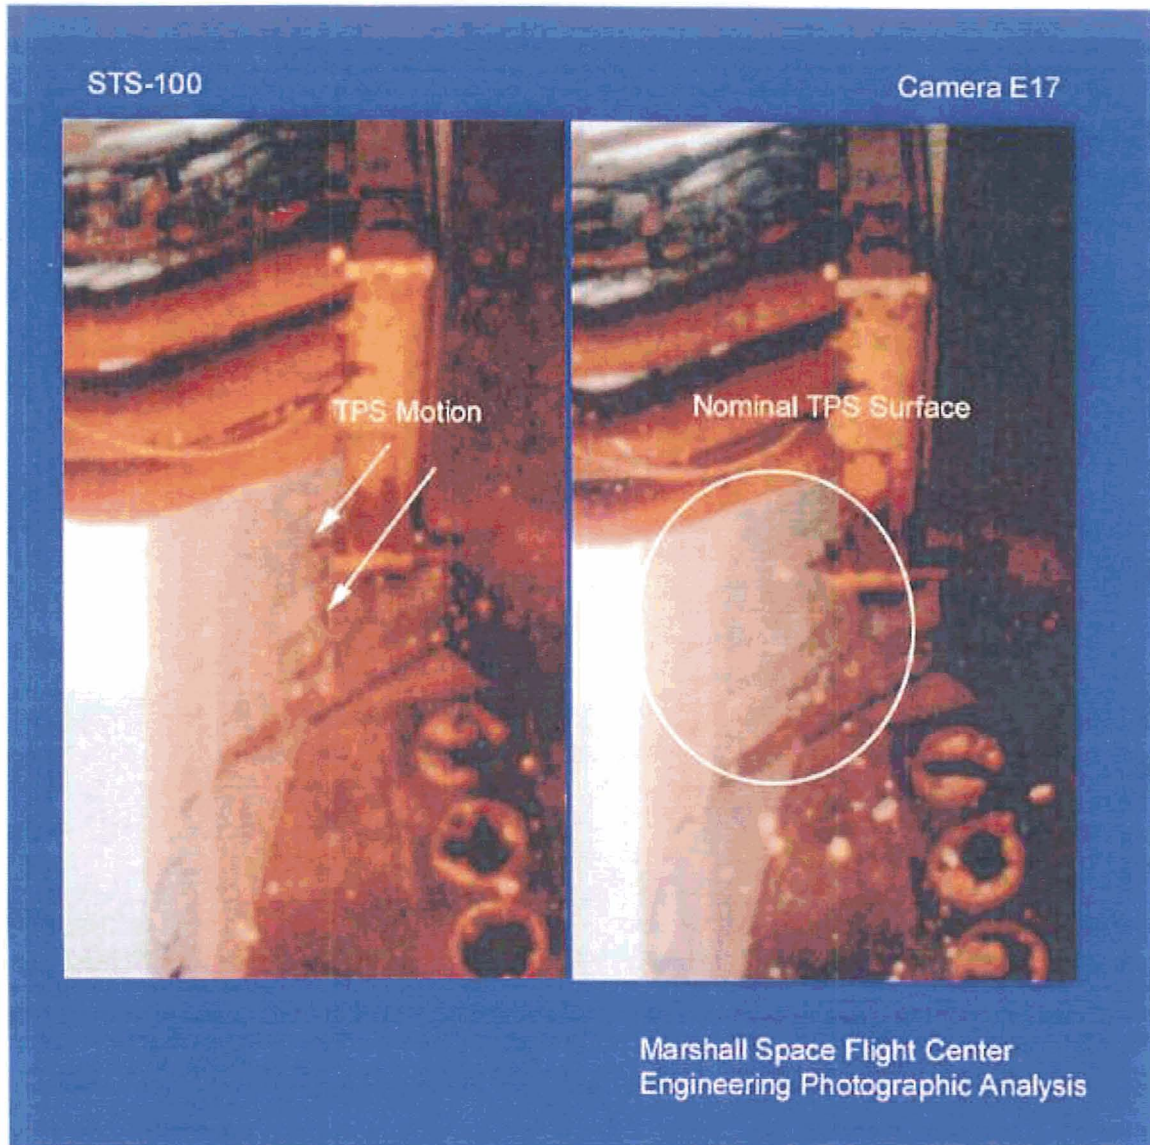
Figure 7. Motion of TPS on Right Stinger Pod

The pulsing and rippling motion of the TPS on the bottom panel of the Right Stinger Pod was also observed, starting at about 109:18:40:38.4 UTC and lasting for approximately 0.3 seconds during SSME startup.

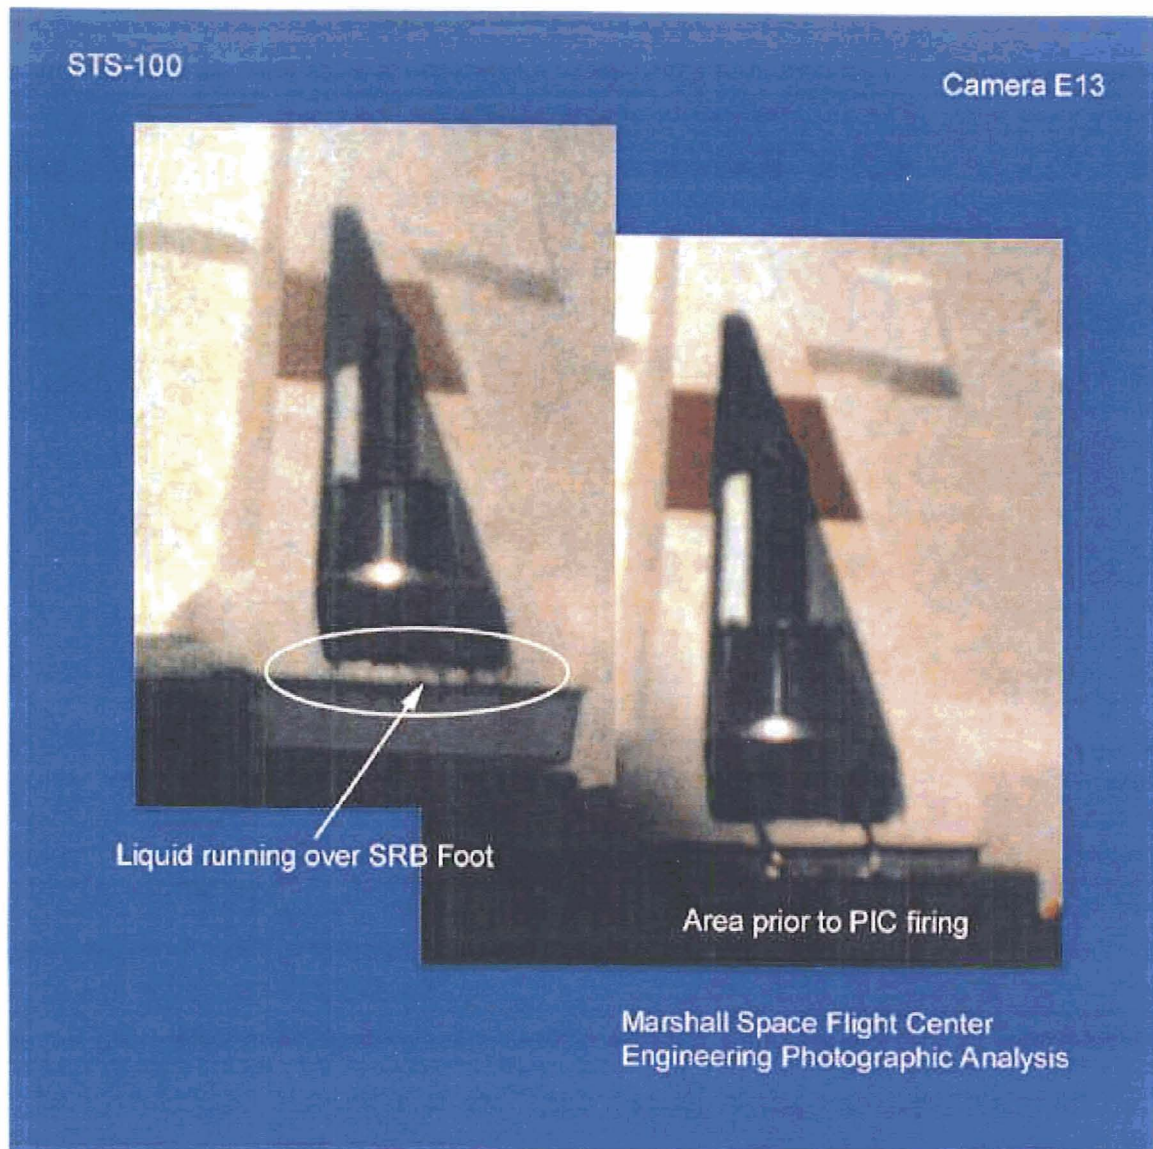
Figure 8. Liquid Observed at Holddown Post M6 Housing

Liquid was observed leaking from the Holddown Post M6 housing after PIC Firing. The image of the flowing liquid in Figure 8 was taken just after liftoff.

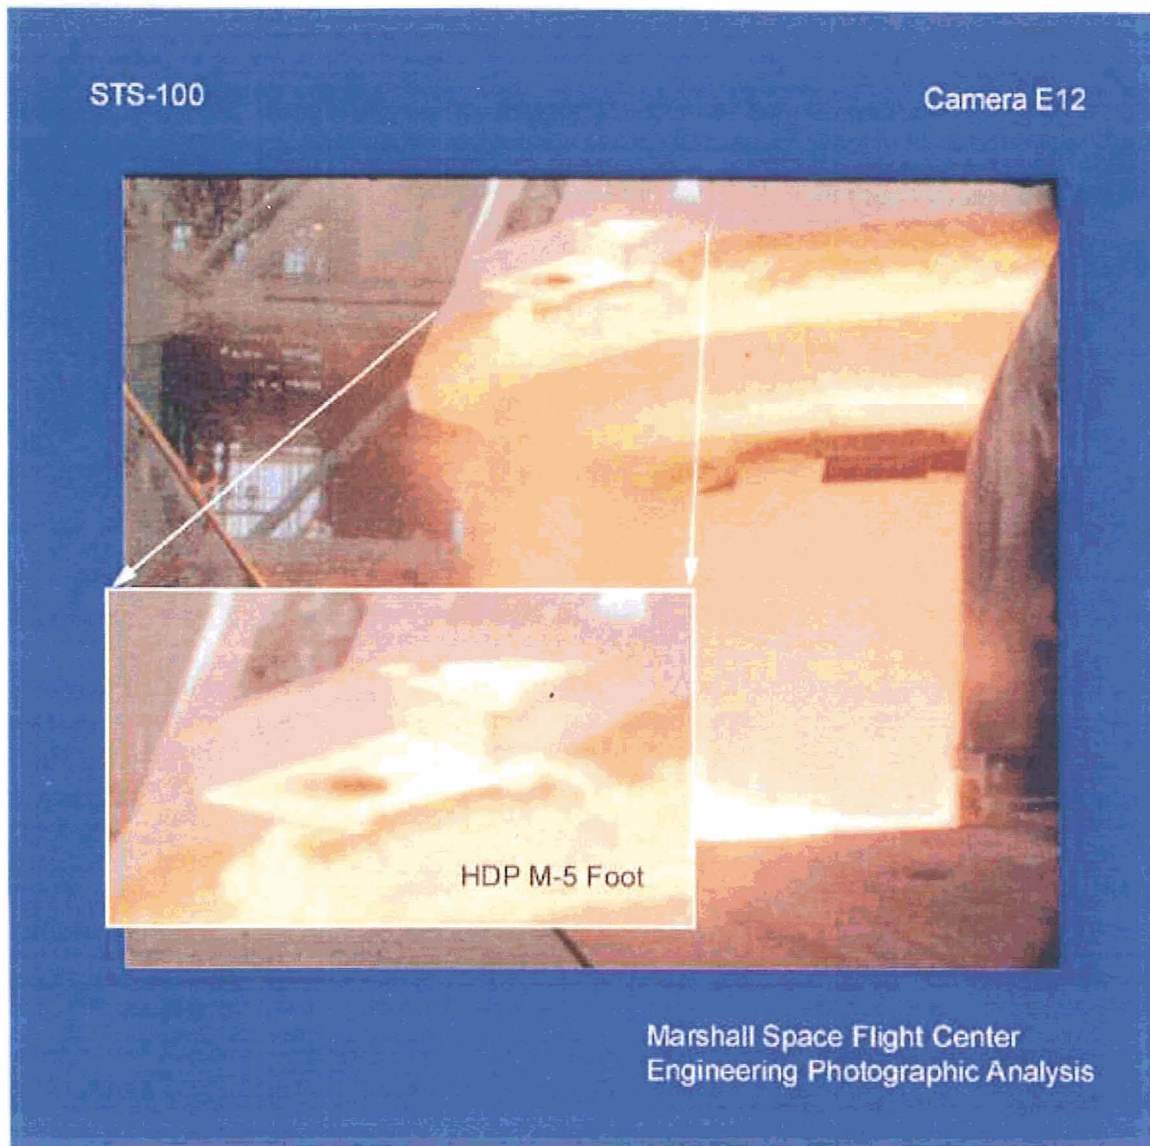
Figure 9. SRB Foot near Holddown Post M5

A photograph of Holddown Post M5 was made just after liftoff to view the condition of the SRB Foot. Post-flight inspection revealed a darkened area on the underside area near the bore. This darkened area was thought to be caused by some material which had burned on the SRB foot. The darkened area described was not evident on the SRB Foot just after liftoff, as shown in Figure 9.

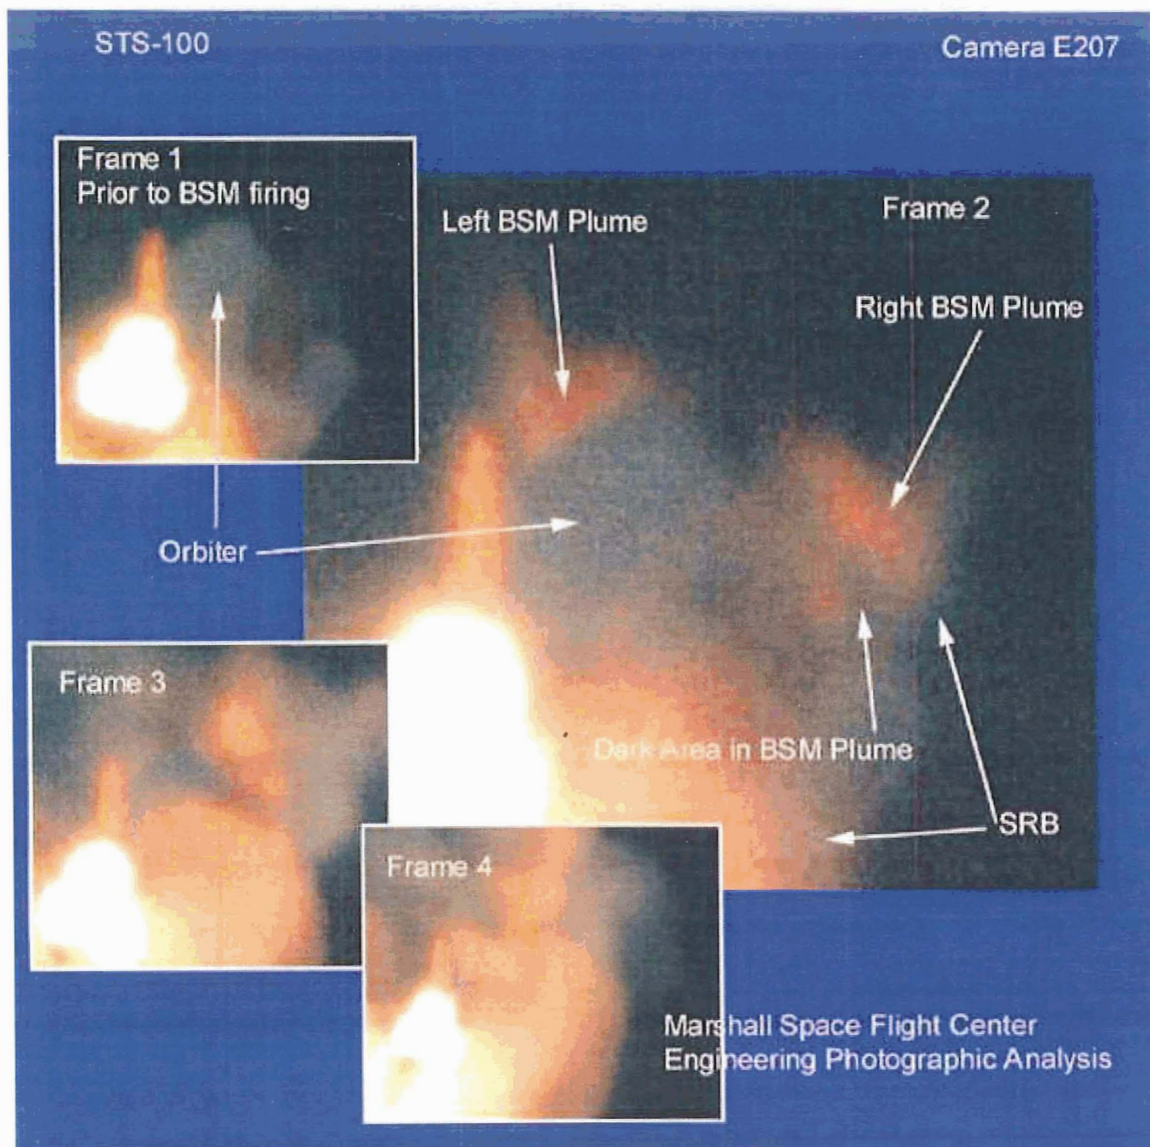
Figure 14. Dark Area in BSM Plume

A dark area was observed in the Right SRB BSM Plume. It was thought this dark area might be attributable to one of the BSM motors that did not completely burn all its propellant, Figure 16. A review of BSM operation at separation for recent missions was performed to address this possibility, Figure 15.

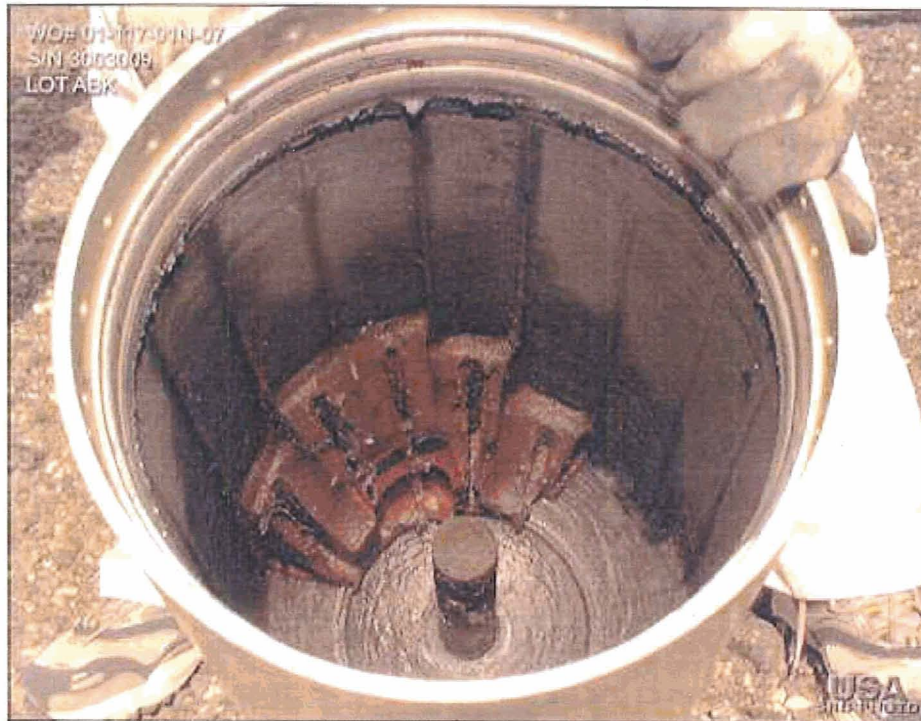
Figure 17. Photograph of Recovered BSM with Remaining Propellant

A photograph of the Right Booster BSM made during post-flight inspection shows the remaining propellant. It was thought that this unburned propellant might have resulted in some visible difference in the BSM plumes.

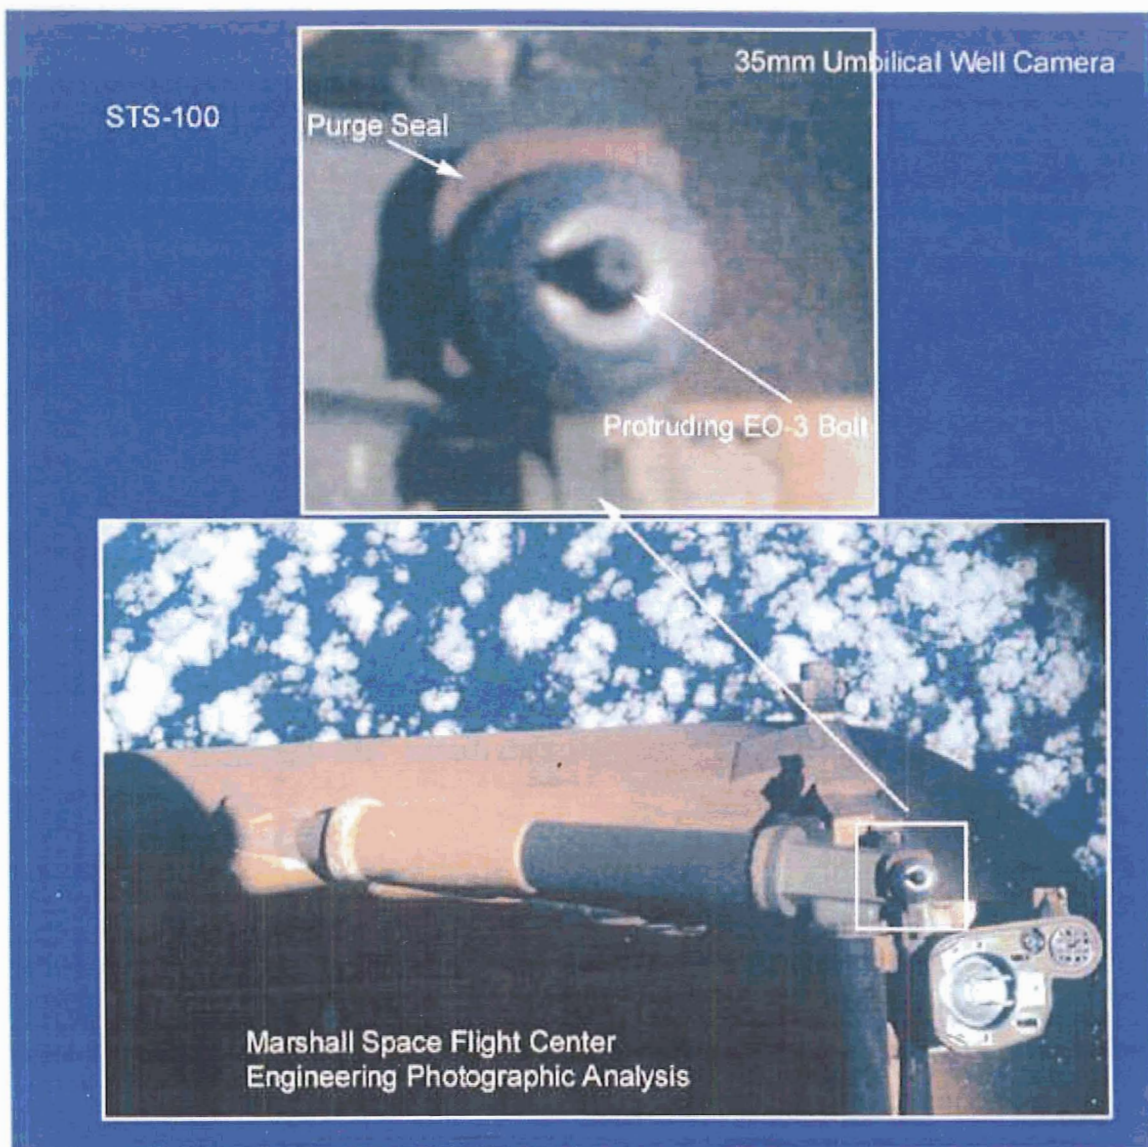
Figure 19. Protruding EO-3 Bolt

The EO-3 separation bolt was observed protruding on this mission. Divoting/popcorning on the Aft Dome appeared nominal.

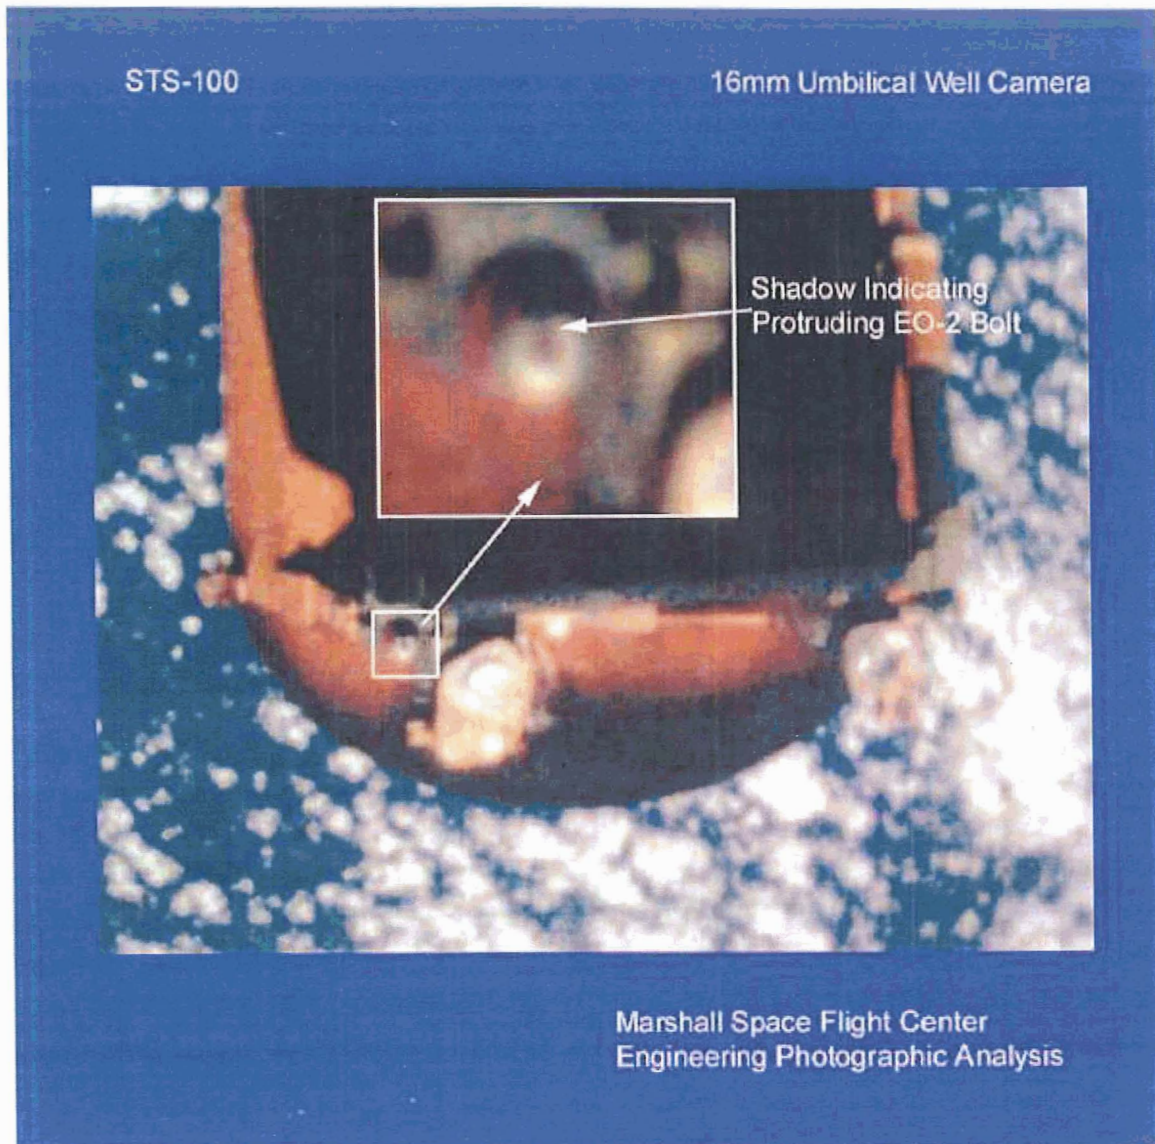
Figure 20. Protruding EO-2 Separation Bolt

A shadow from the EO-2 separation bolt was observed, indicating that the bolt was protruding. The shadow cast is similar to the shadow from the protruding EO-3 separation bolt.

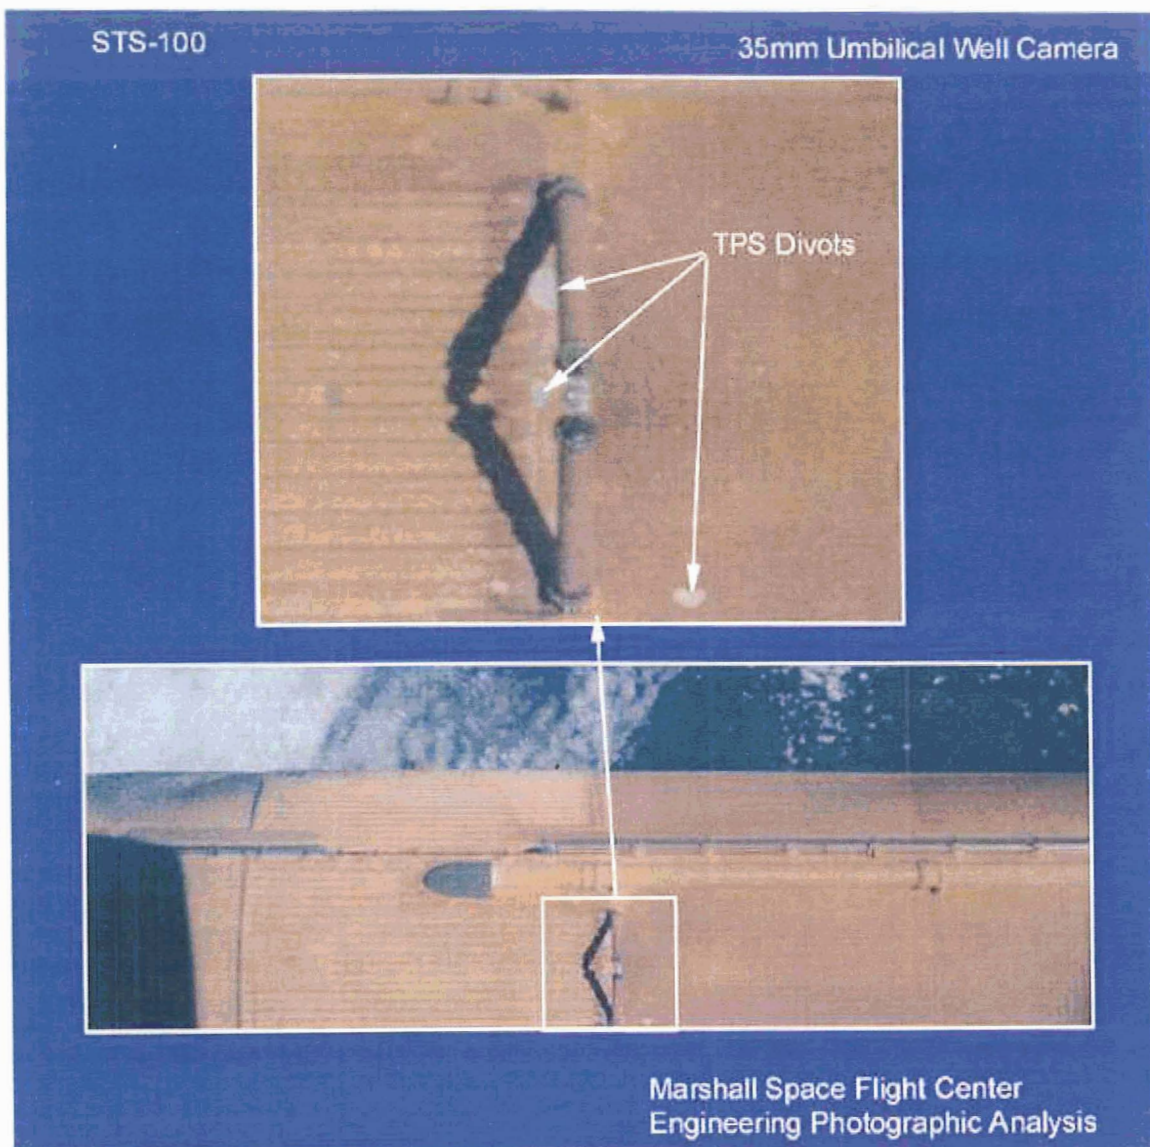
Figure 22. ET TPS Divoting near the Bipod

Several TPS divots were noted near the ET/Orbiter Forward Attach Bipod. Two divots directly beneath the bipod and one just aft and right of the bipod were observed.

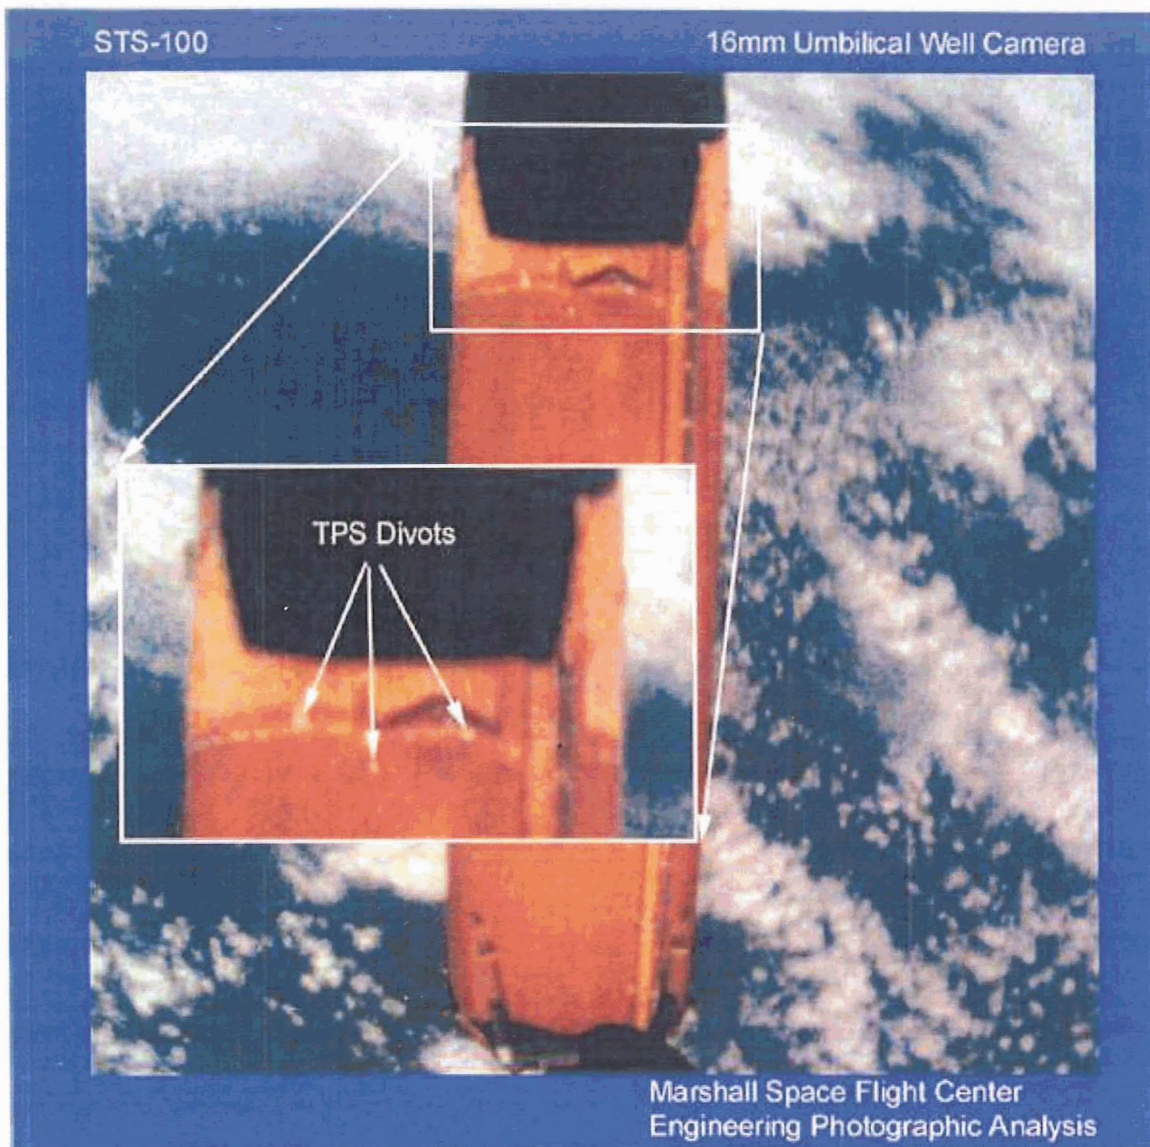
Figure 23. ET TPS Divoting

Divots were observed in the vicinity of the LH2 tank to Intertank flange.
